Water Quality

Urban Sustainability Project
Case Study 5

Council: Cootamundra Shire Council
Theme: Water Quality
Project Name: Boundary Road to Muttama Creek Drainage Improvements

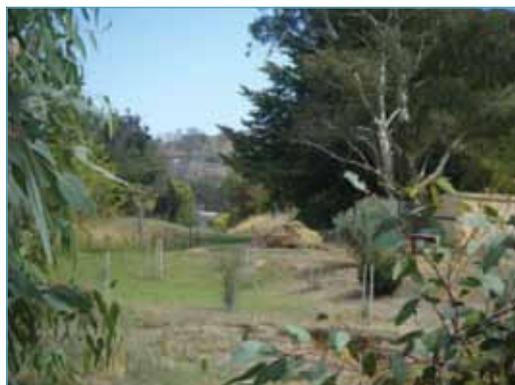
Erosion and scouring was a problem prior to the project

The drainage improvements undertaken included the construction of rock mattress and gabion structures.

These were located at the discharge end of the Boundary Road to Muttama Creek drain. The gabions were designed and installed to act as a gross pollutant trap by reducing the velocity of the water to allowing the sediment to drop out. They are easily cleaned which will minimise ongoing maintenance. Installation was done by Cootamundra Shire Council together with Revegetation and Erosion Control Services.

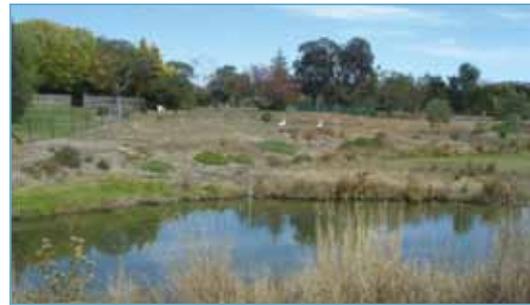
The point at which the drainage water enters the pond on the Muttama Creek. The drainage water eroded the Creek banks and the works will direct water into the pond and provide scour and erosion protection

The project involved excavation at the junction of the open drain and Creek to a depth suitable to install rock filled gabions and concrete edging to protect the Creek's banks and constrict the open drain flow to one manageable location.

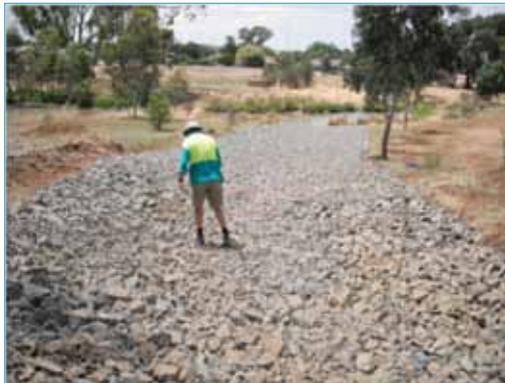
Installation of the rock mattress

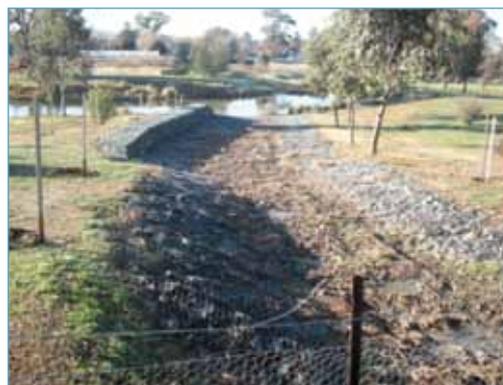
Completed construction

The project was completed on schedule. The gabions are functioning well, with numerous rubbish items and leaves being collected. The mattresses and gabions have also stopped the erosion problems and sediment build up into the creek.

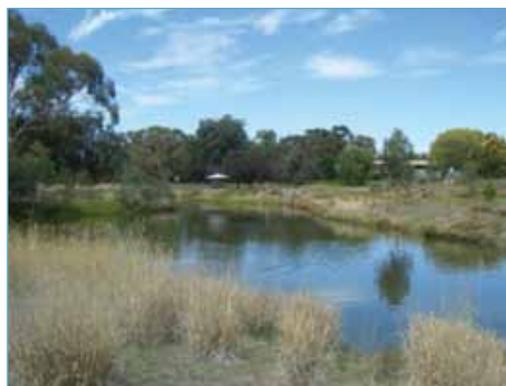
The receiving pond on the Muttama Creek that is protected from pollutants as a result of the project

The installation of the rock mattresses and gabions has reduced the amount of pollutants and sediment entering the Muttama Creek. Consequently the Creek's water quality is greatly improved, which in turn will encourage the return of various native flora and fauna. Maintenance on the rock mattresses and gabions is fairly minimal and inspections are carried out periodically and after significant storm events. Damaged areas are repaired as soon as practicable using fencing wire or geotextile. Aesthetically they are quite pleasing as the rock gives the structure a natural, watercourse look.
